# ROOF INSPECTION & MAINTENANCE REPORT

- Main Roof Materials – 10" x 18" & 12" x 24" Vermont Green slate
- Flat Roofs – Copper flat seam (FB Installed – 2010)
- Garage Roof – EPDM (Installed by others)
- Flashings – Copper
- Gutters – Copper built-in
- Downspouts – 3" x 4" copper box
- Chimney – Brick

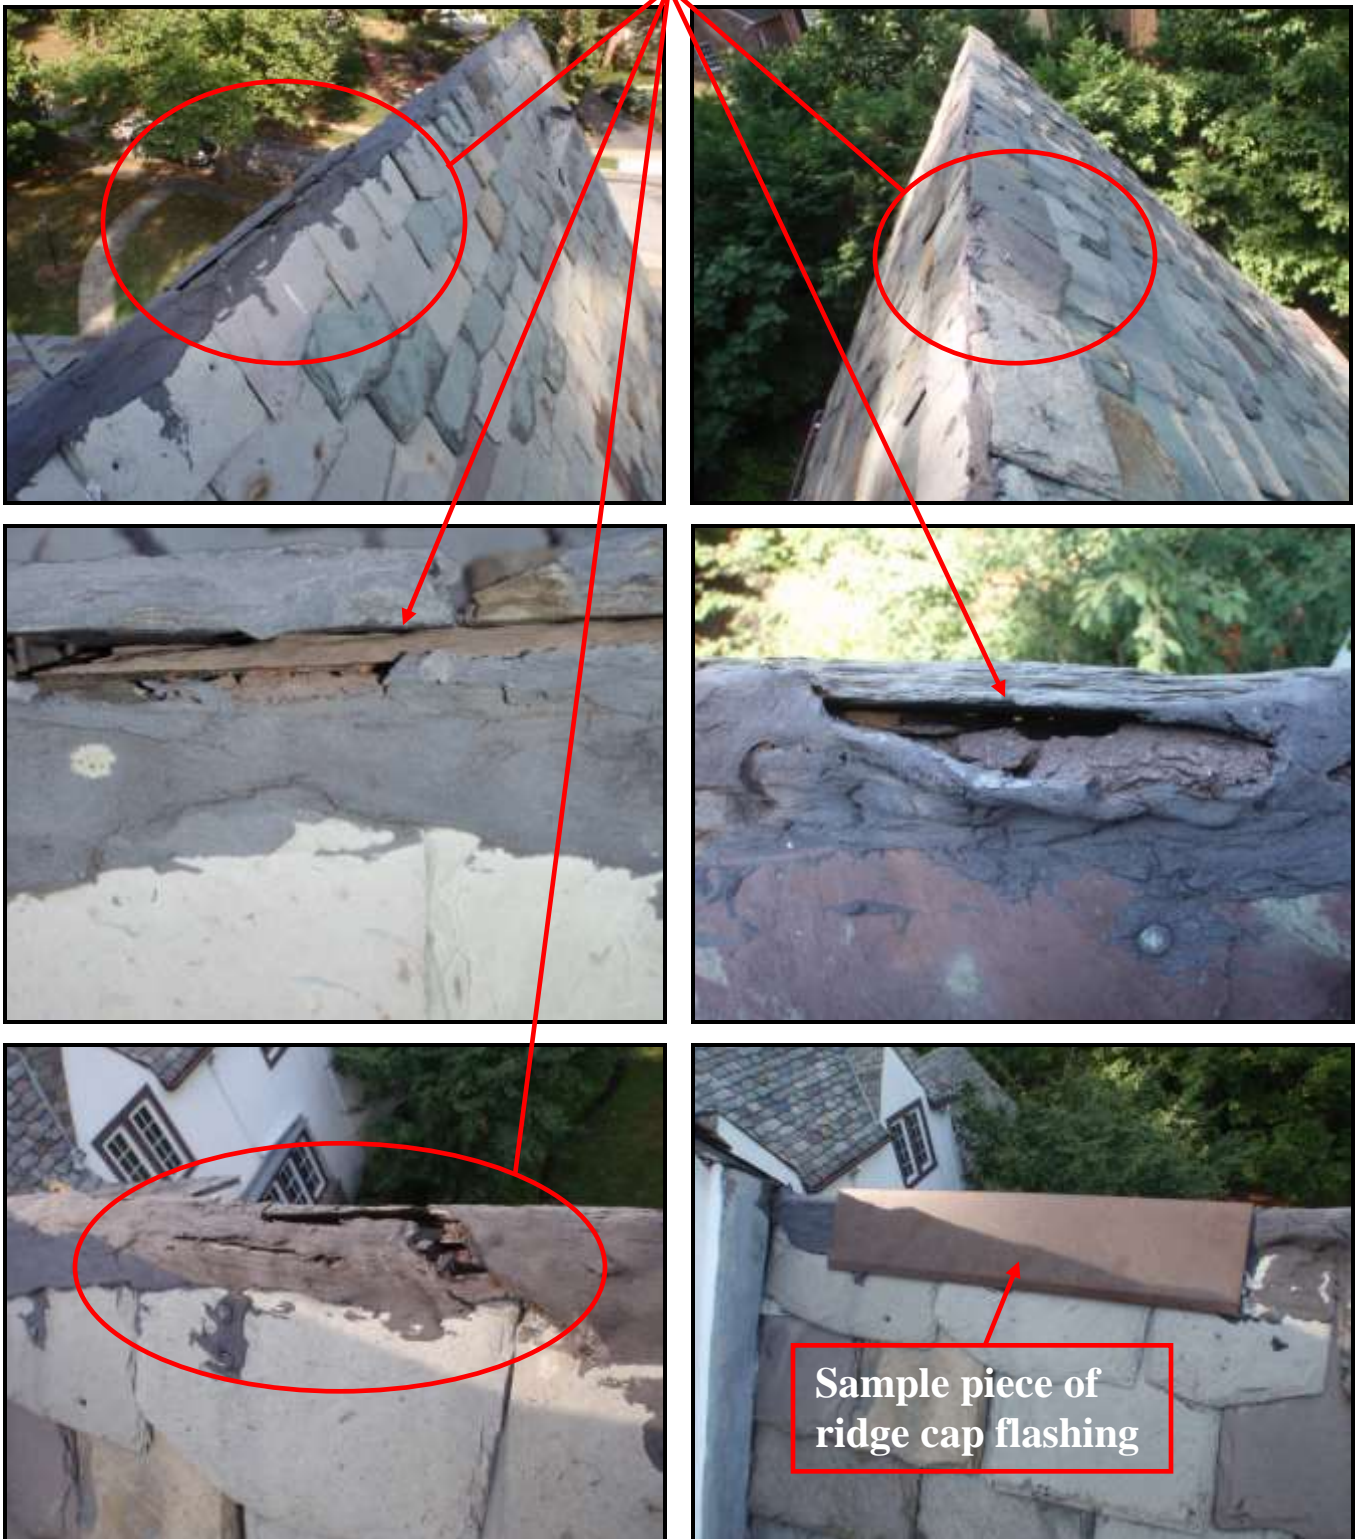
1. Slate roof is in very good condition; however there are many areas at the ridge where the cement is split wide open & nails backing out (this will allow water infiltration and can cause more extensive damage)

1. Dig out & re-cement all ridges or install ridge cap flashing
  2. Pull & repair exposed nails along the remaining eaves of the house
  3. Install custom spout head & splash guard or a diverter at lower end of front valley to contain water overflow
  4. Install snow rails at front valley to hold back & contain snow & ice above the front entry door.
- ***Your roof is in good condition at this time. Completing the above recommended repairs, as well as, regular inspection and preventative maintenance can prevent leaks and other roof related problems, protect your home's interior and extend the life of your roof.***

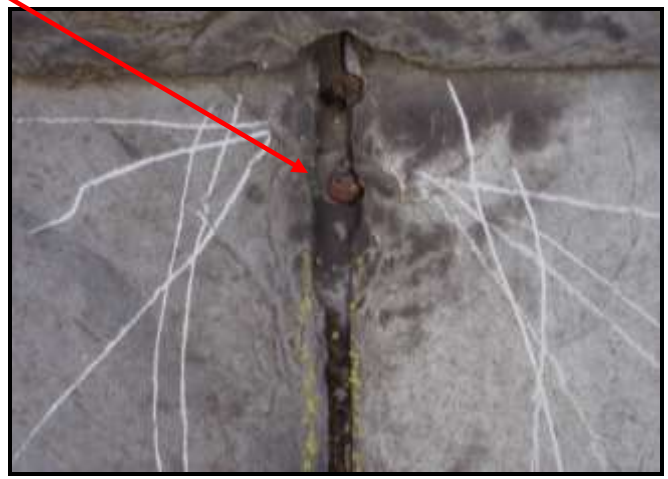
2. Eave slate all around house have been nailed through; probably done when old gutter screens were installed; these nails are rusted and difficult to find (these can allow water to drip through at the eaves and cause leaks)

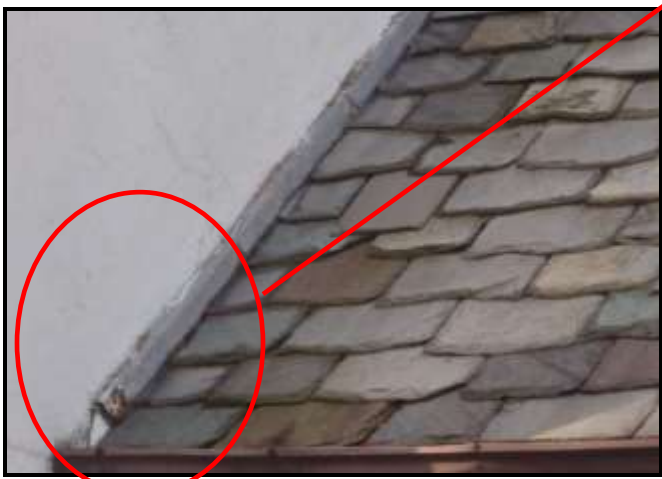
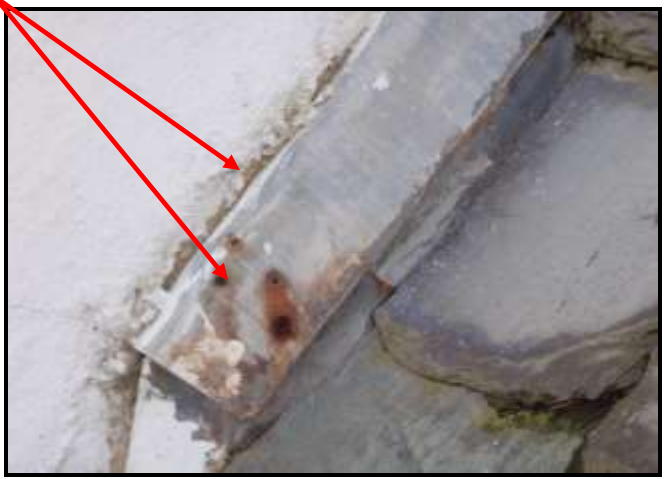
3. Caulk at wall flashings was split or missing; there are a few nail holes in the flashing also

1. Replaced two broken slates
2. Pulled exposed nails at bottom course of slate above leak area & flashed holes
3. Caulked wall flashings
4. Cemented open spot at ridge

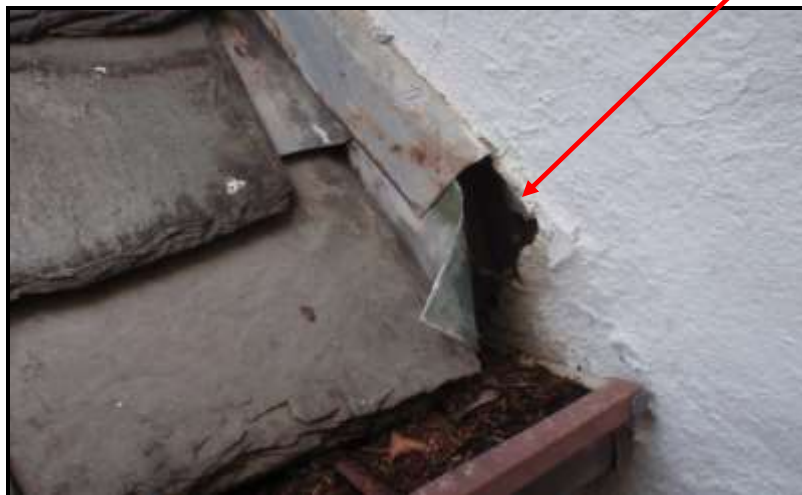
4. There is a hole behind one area of wall flashing that is missing
